# Lone Star Home Inspections

## PROPERTY INSPECTION REPORT

**1234 Main Street, Palmer TX 75152**

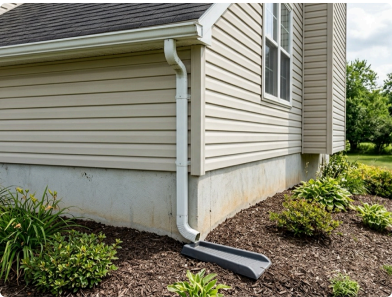
1: Excessive moisture next to foundation - Standing water

Major

North / West side of structure (North patio at corner)  
There appears to be excessive moisture / signs of excessive moisture present next to the foundation. The grading and drainage should be adjusted to facilitate better drainage.

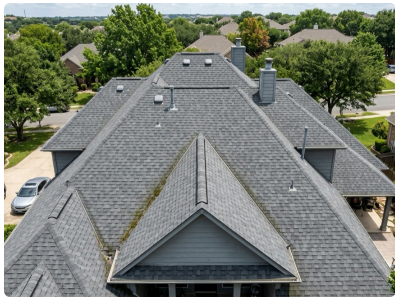
Types of Roof Covering: Asphalt shingles

Viewed From: sUAS / Aerial Drone

Visible portions of the roof covering were reviewed to assess general function, condition, and serviceability.

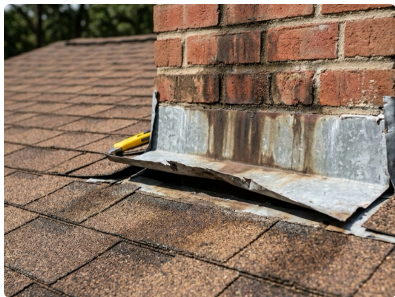
**1: Kick out flashing not installed**

Major

Kick out flashing is not installed where the roof intersects the exterior wall(s).

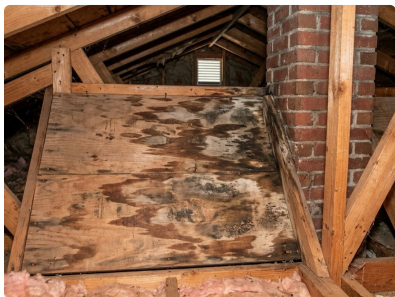
**1: Eave/cornice vents/baffles not installed**

Minor

Eave/cornice vents/baffles are not installed to allow free flow of air from the soffit vents into the attic space.

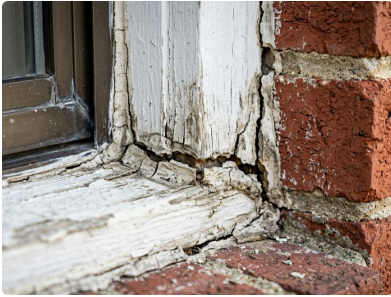
## 1: Walls - Caulk / sealant not installed/separated

Minor

Caulk / sealant is separated or not installed. This could allow for air, water/moisture, and/or pests to enter the structure.
